Fatigue crack growth rates of  
high-magnesium aluminum-magnesium alloys  
as influenced by solution treatment time and  
alloy content.

# THESIS

FATIGUE CRACK GROWTH RATES OF HIGH-  
MAGNESIUM ALUMINUM-MAGNESIUM ALLOYS AS  
INFLUENCED BY SOLUTION TREATMENT TIME  
AND ALLOY CONTENT

MASTER OF SCIENCE IN MECHANICAL ENGINEERING

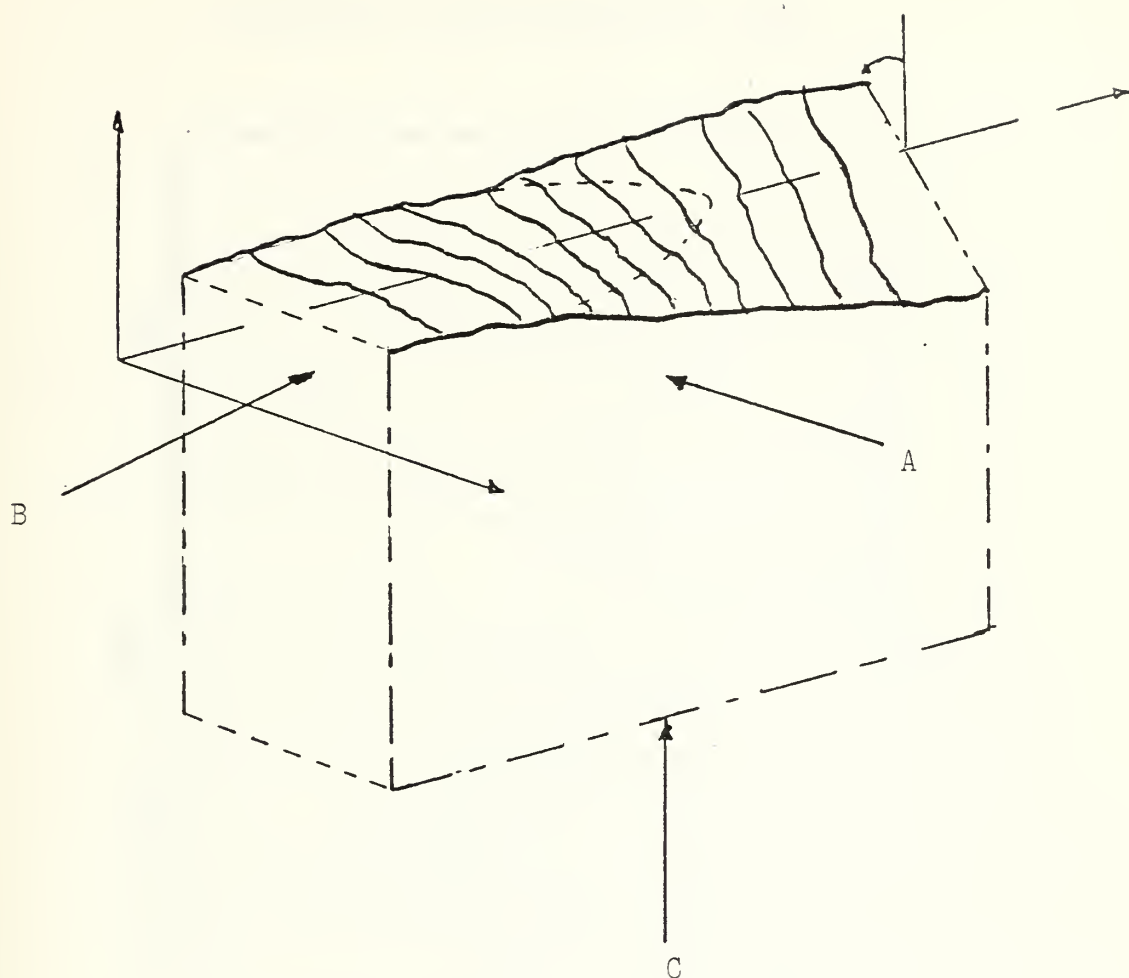
FIGURE 4.10 OPTICAL MICROGRAPH LOCATIONS FOR THE 9 AND 25 HOUR SOLUTION TREATED Mn CONTAINING ALLOYS, AND Cu CONTAINING ALLOYS.

Optical micrographs of the nine hour and twenty-five hour solution treated alloys are shown in Figures 4.8 and 4.9 respectively. The relative locations of the micrographs with respect to the crack surface are shown in Figure 4.10. There is little difference in the micrographs between the two

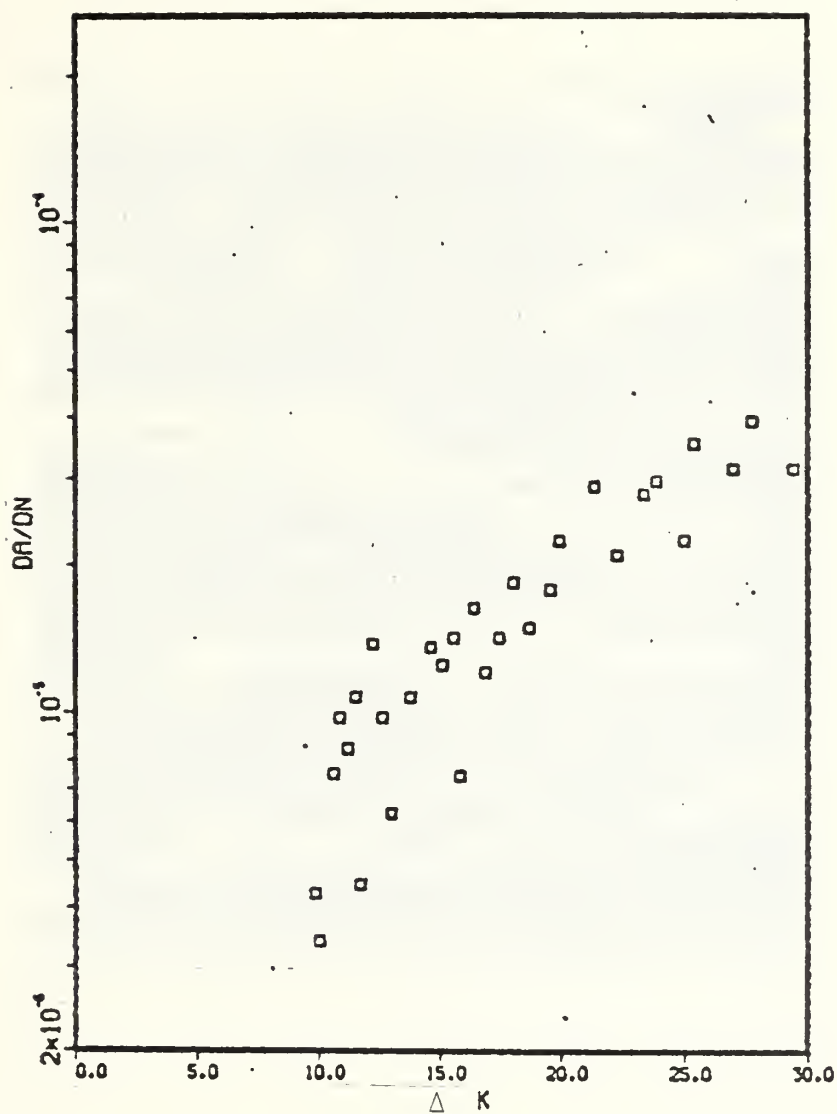
FIGURE 4.11 FATIGUE CRACK GROWTH DATA FOR Al-8.14 WT PCT  
Mg-0.40 WT PCT Cu ALLOY.

Fatigue crack growth data for the Al-8.14 wt pct Mg-0.40 wt pct Cu alloy are presented in Figure 4.11. The data for this alloy indicates a higher threshold stress intensity ( $\Delta K = 10 \text{ ksi } \sqrt{\text{in}}$ ) for fatigue crack growth than either the 7075-T6 or Al-10.2 wt pct Mg-0.52 wt pct Mn alloys. At higher stress intensity values, crack growth rates for this alloy are much reduced in comparison to the manganese containing alloy and are also lower than those measured for the 7075-T6 in this research. Crack growth rates were measured at  $\Delta K$  values up to  $30 \text{ ksi } \sqrt{\text{in}}$ , where the growth rate measured was approximately  $3 \times 10^{-5} \text{ in/cycle}$ . This reflects a higher degree of toughness in this alloy. It must also be noted, however, that this is the lowest strength material of the three different compositions evaluated in this research and is certainly a factor in the higher apparent toughness of this alloy. At this point, the appropriate strength toughness data has not been obtained to facilitate comparison of these alloys amongst themselves or with conventional alloys.

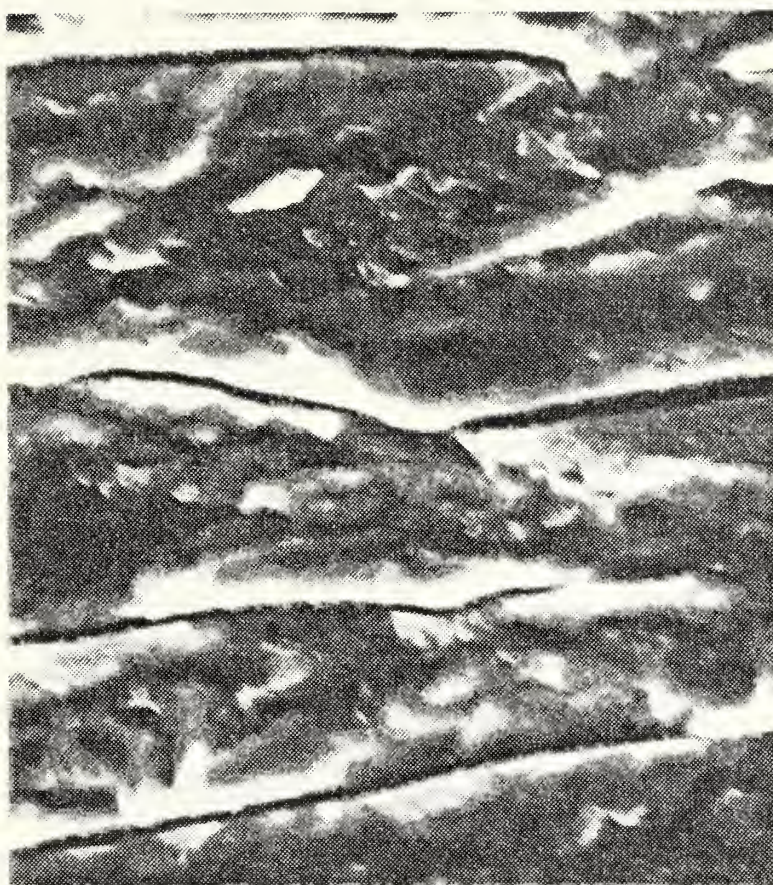
FIGURE 4.12 SCANNING ELECTRON FRACTOGRAPH FOR THE Al-8.14  
WT PCT Mg-0.40 WT PCT Cu ALLOY

Scanning electron microscopy (SEM) investigation of this alloy was conducted and the results appear in Figure 4.12. The fatigue crack surface is similar in general appearance to that of the 7075-T6 alloy. There are, however, two important differences. First, the Al-8.14 wt pct Mg-0.40 wt pct Cu alloy exhibits sharply defined ridges parallel with the direction of crack growth and second, there do not appear to be any large dimples in this alloy. The ridges correspond to grain boundaries and suggest that the crack front tends to split such that the crack does not remain planar.

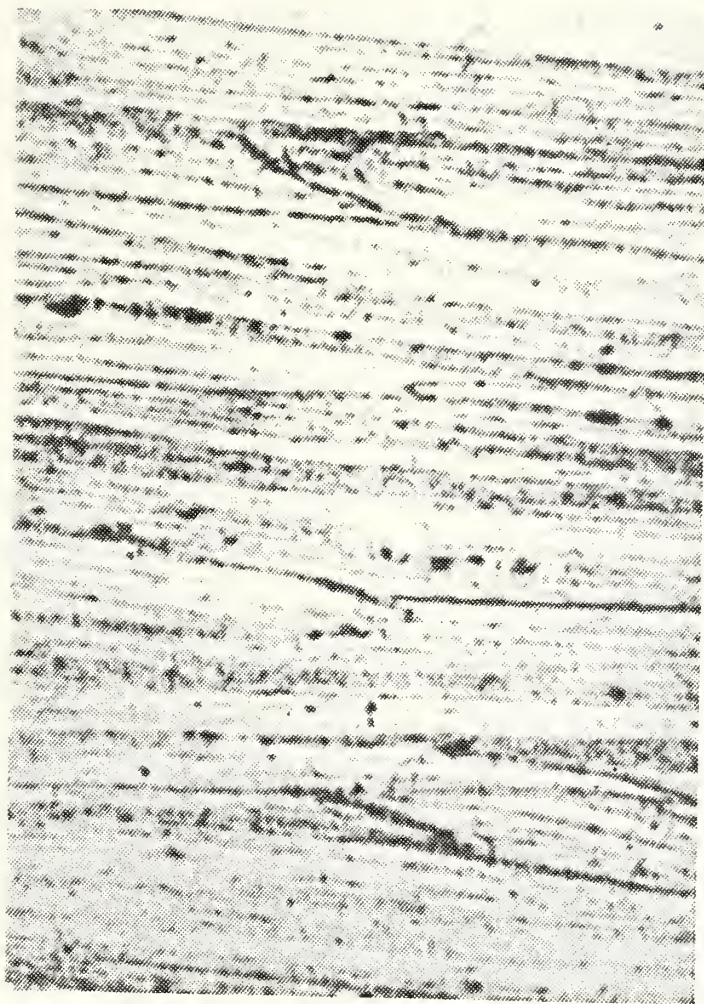
FIGURE 4.13 OPTICAL MICROGRAPH FOR THE Al-8.14 WT PCT  
Mg-0.40 WT PCT Cu ALLOY

The optical micrographs (Figure 4.13) indicate the presence of flattened elongated grains. The tendency of the crack to split onto different planes would retard crack growth but the elongated grain structure would suggest that this enhancement in crack growth resistance would not be isotropic. The dimples on the 7075-T6 fracture surfaces are probably the result of voids nucleation at large constituent particles associated with the Fe and Si present in this alloy. The Fe and Si content in this alloy is much lower than that of 7075-T6 and hence the constituent particles are not present to be associated with such void formation.
